Inventive Tricks and Fixes Aboard the ISS

MacGyvering Station

International Space Station

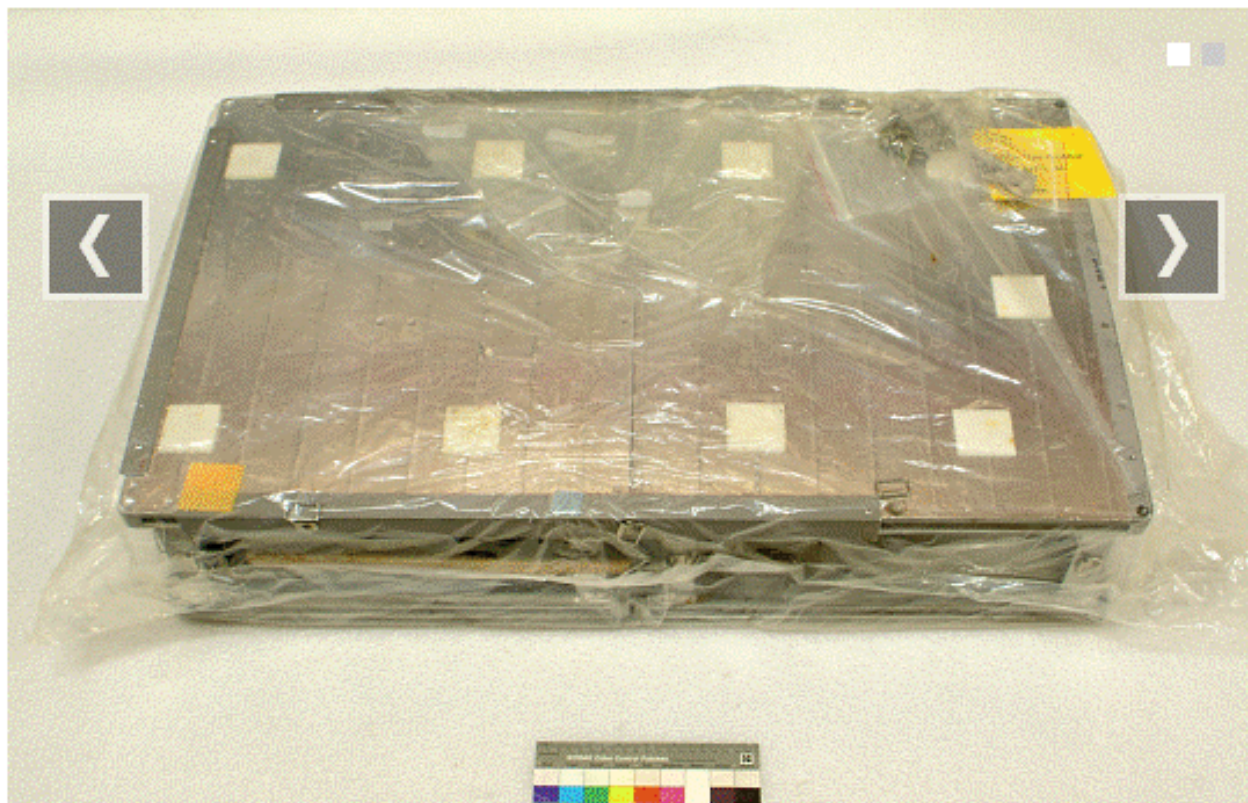
The Window Box (2004 / Inc 9)

- **Problem:** crew uses a hose to space as a handhold to look out the window.
- **Impact:** station leaks too much.
- **Workaround:** build a box around the hose.
Originally it was to be built from on-orbit supplies, but eventually a kit to build the box was flown.

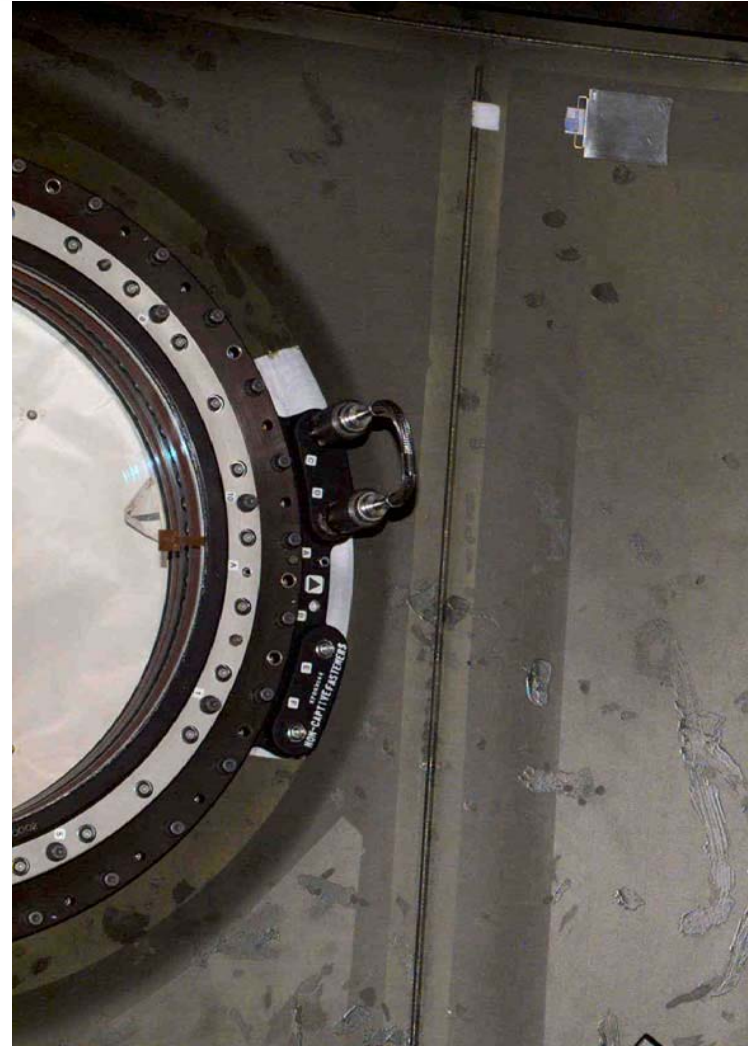
Window Box Parts List

Table 1 - Lab Window Flex Hose Cover Kit contents

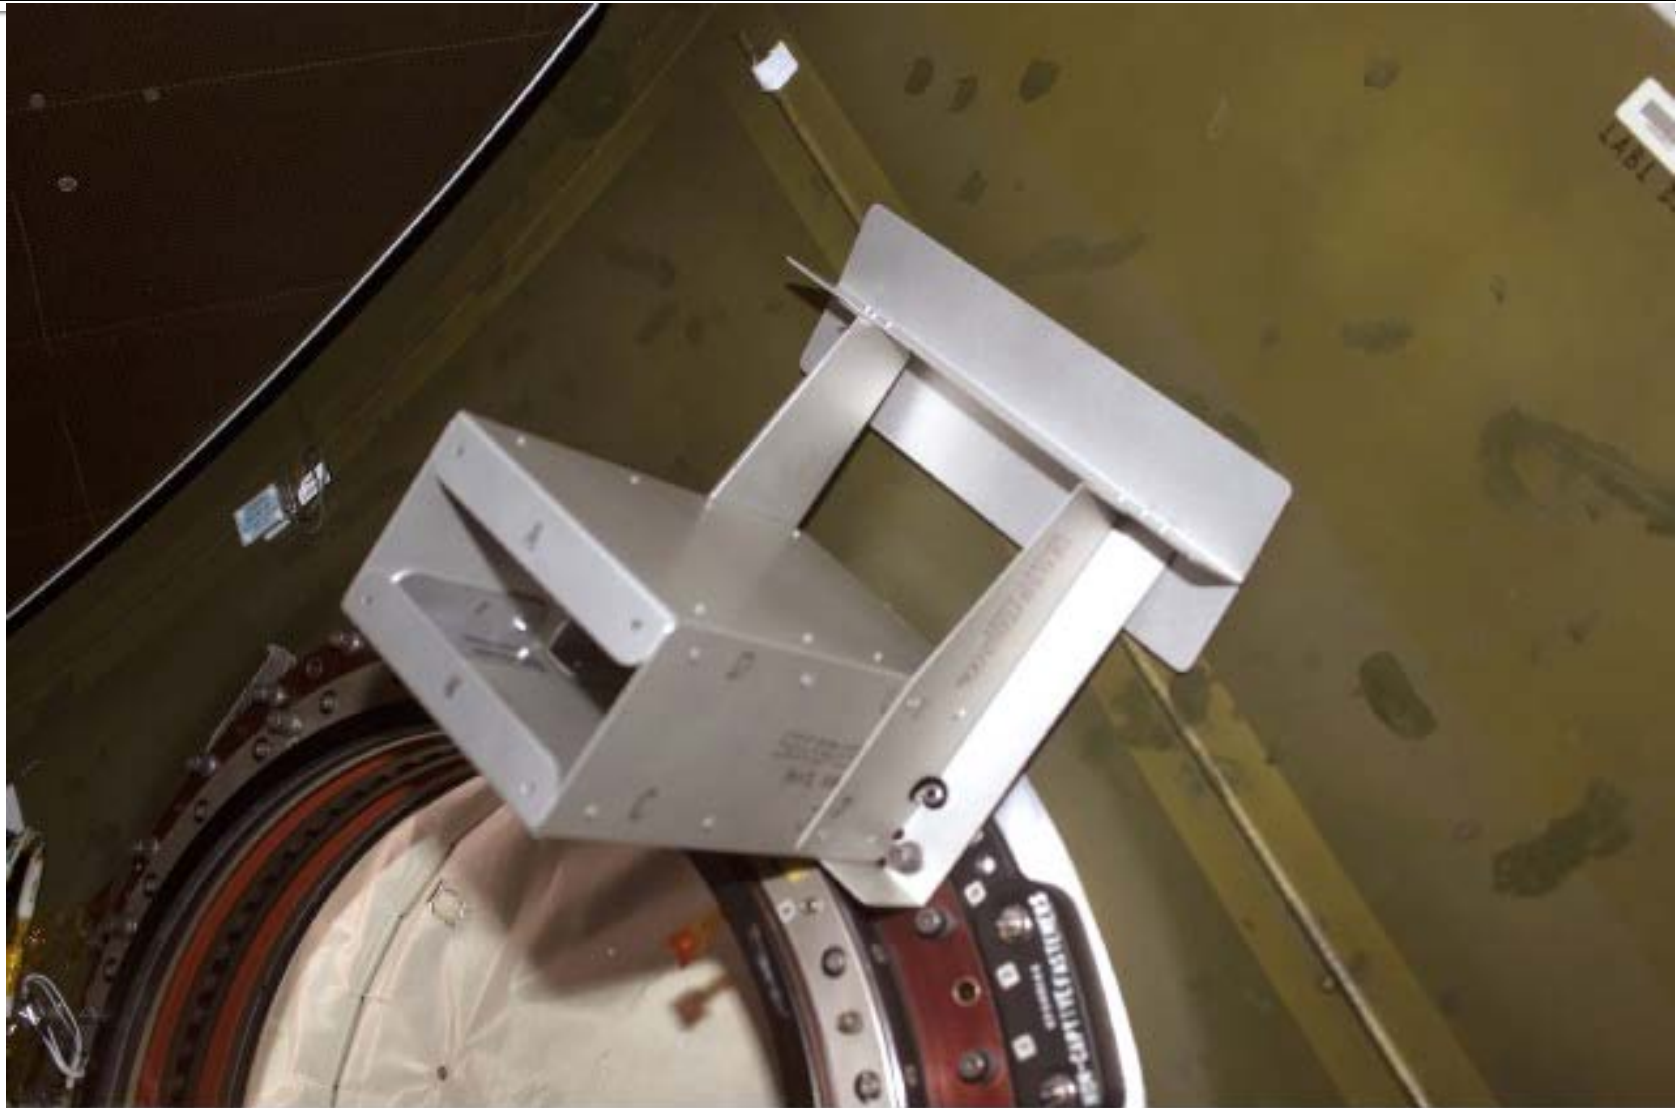
ISS009E17278

The Window Box

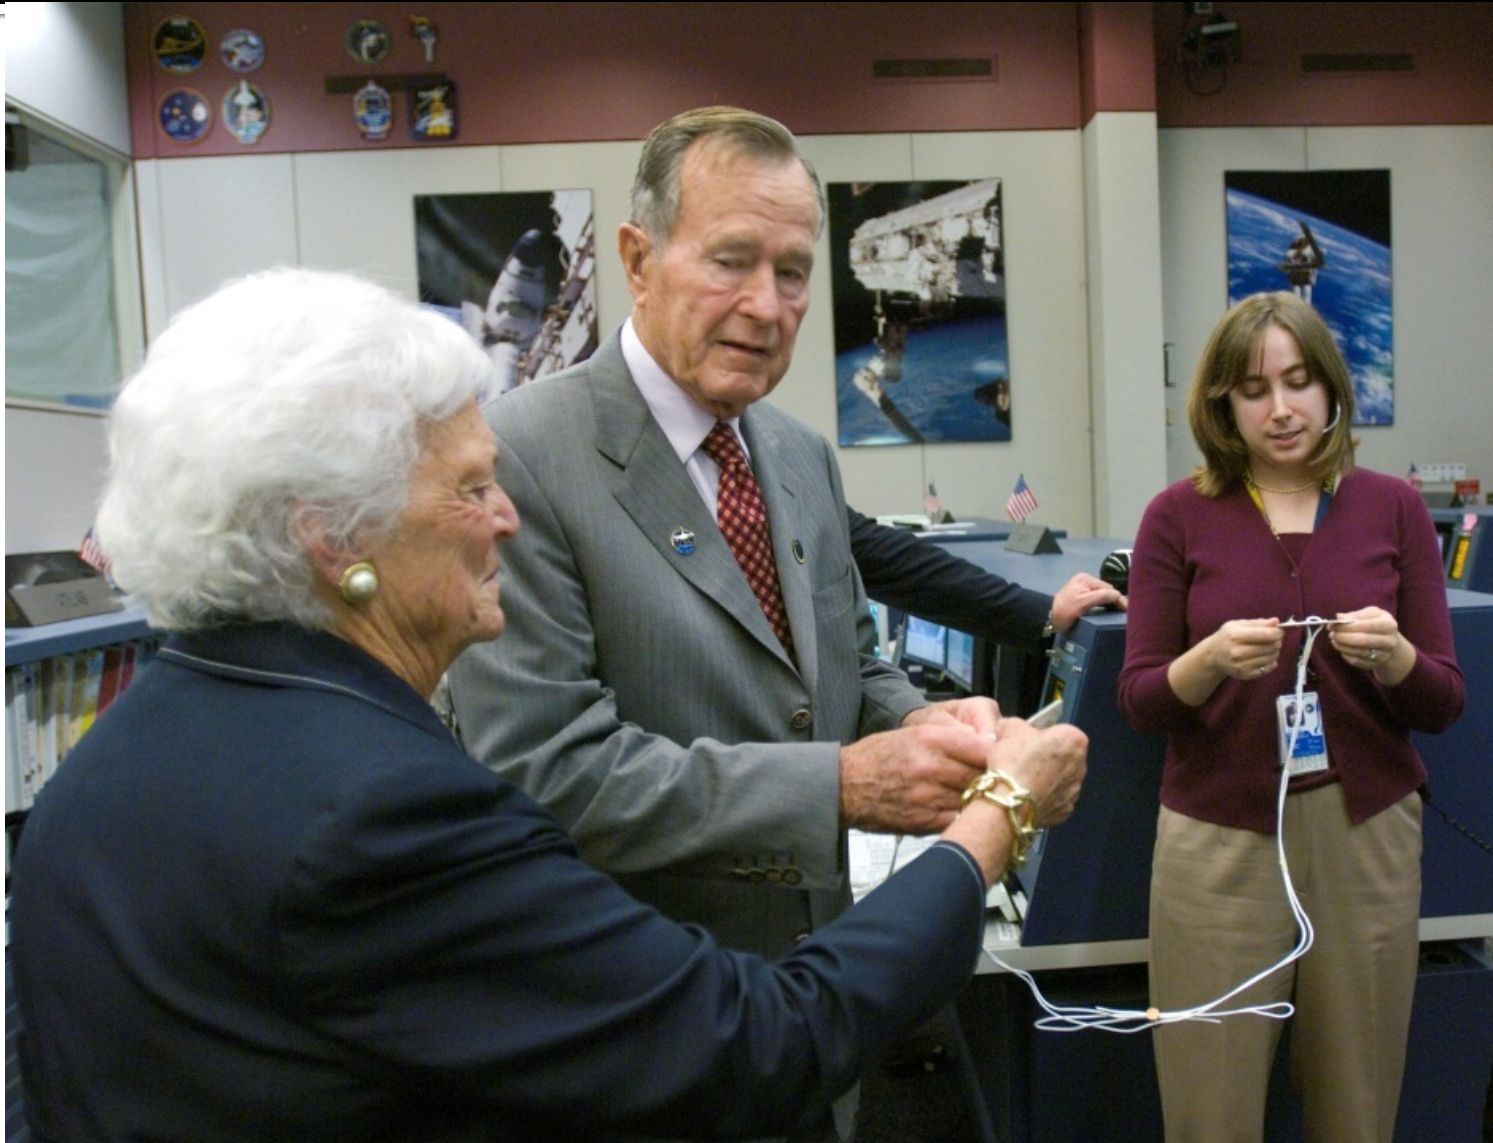
Solar Array Hinge Stabilizers ... a.k.a. Cufflinks

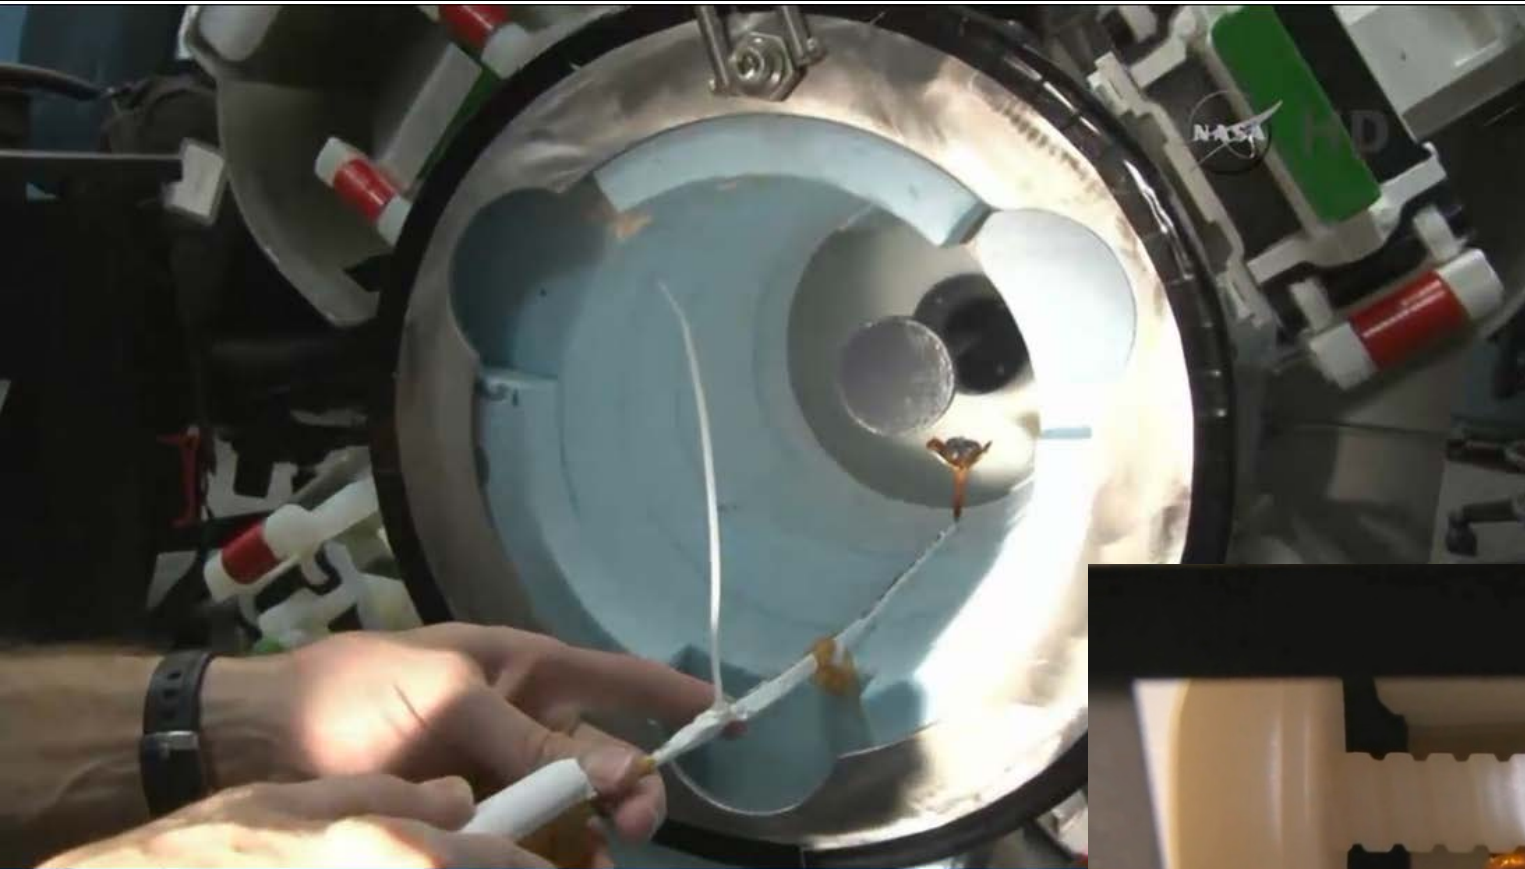
Training to use the BLT on ground mockups of the LEE

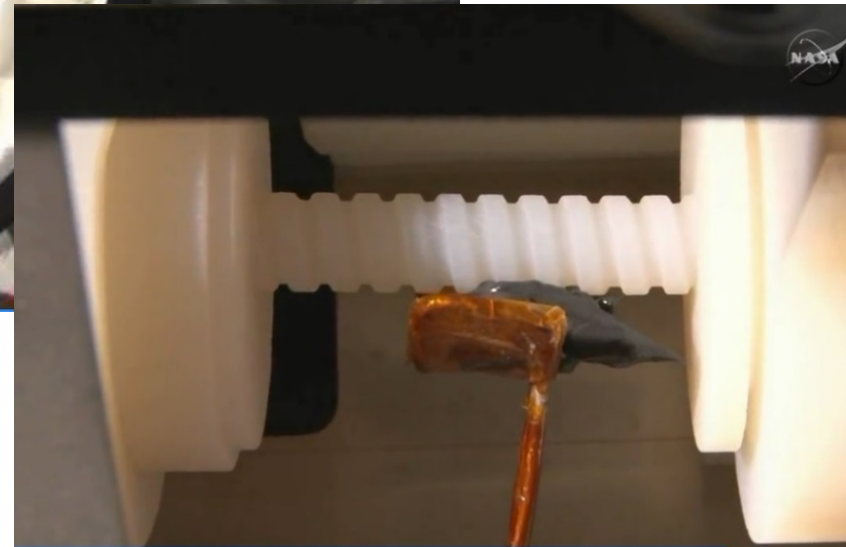
BLT On Orbit

The as built BLT on orbit, looked almost exactly like the ground built unit

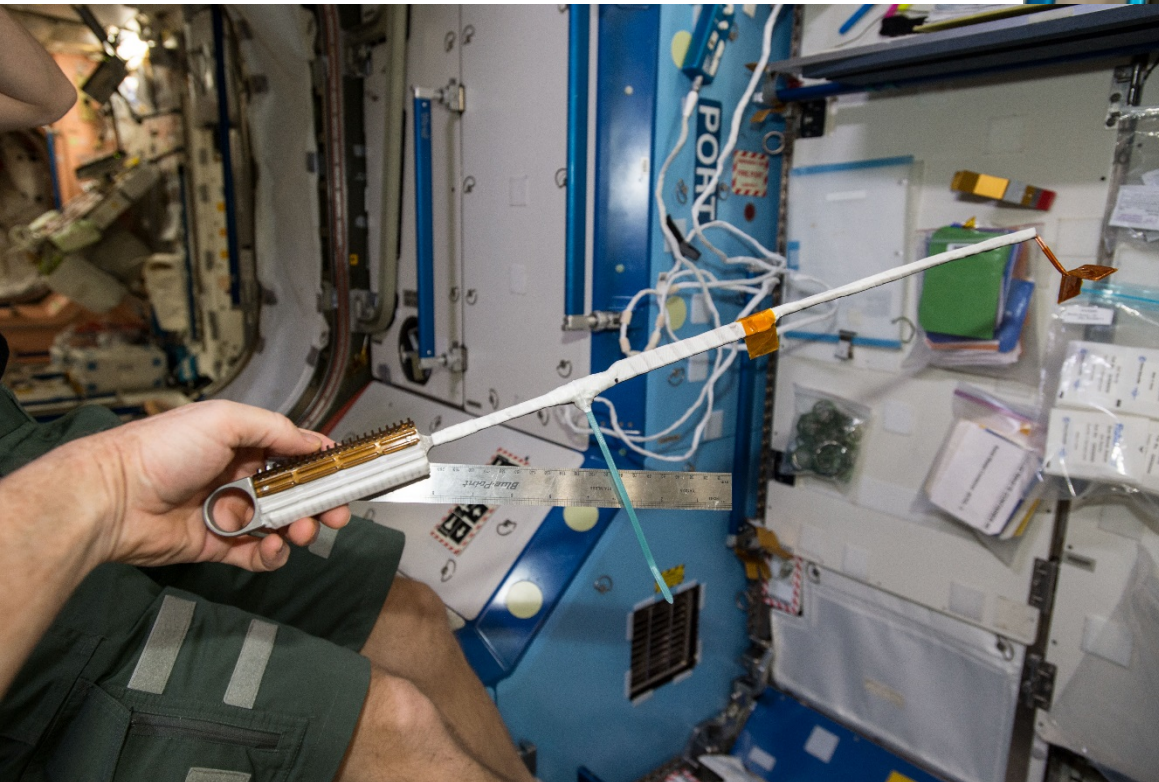
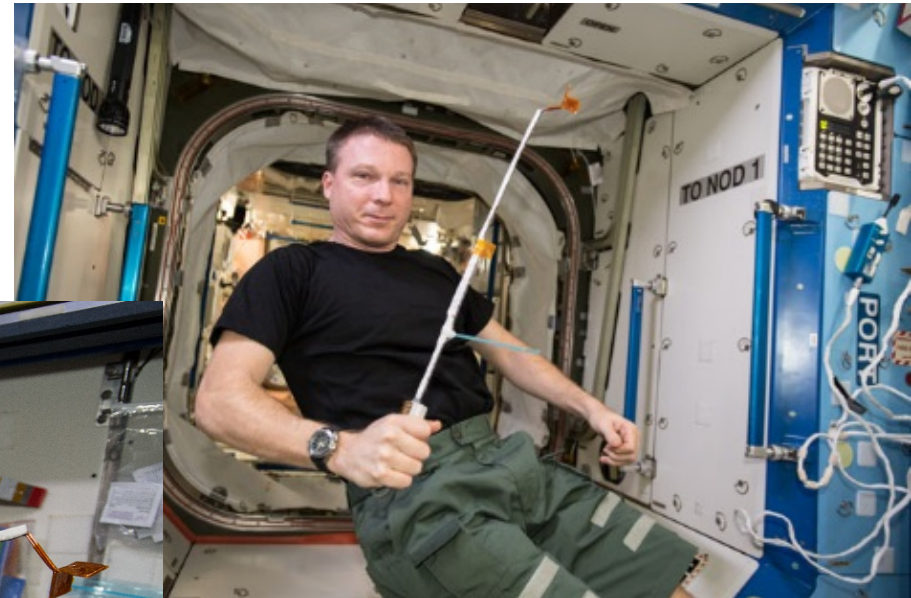
BLT In Use

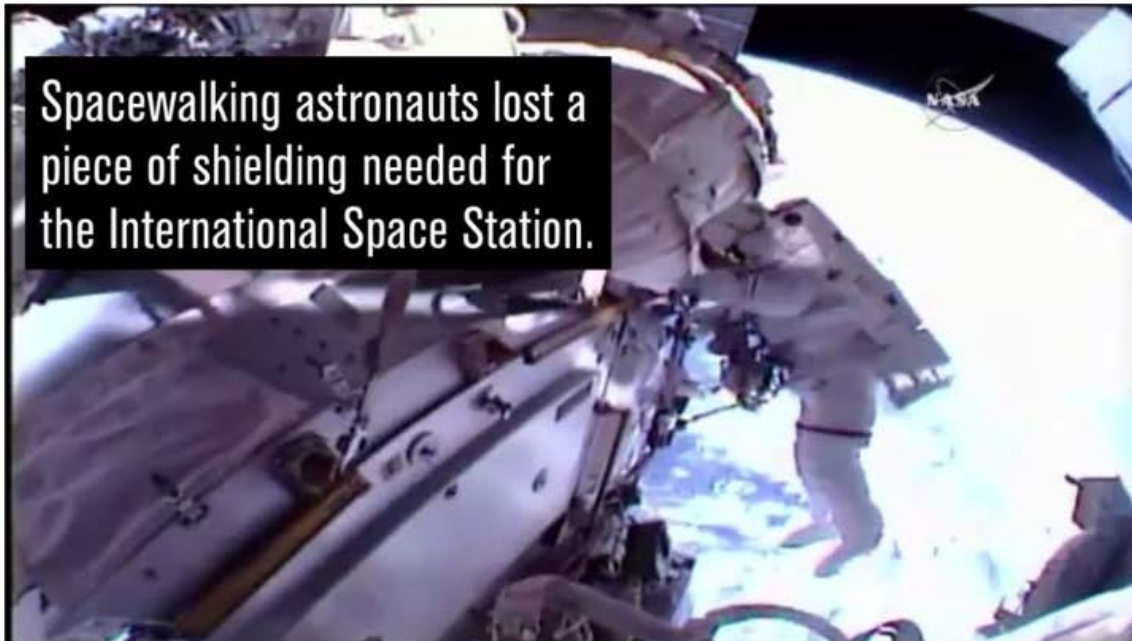
Spacewalkers lose piece of shielding, use MacGyver-like plan for patch instead

Whitson and Shane Kimbrough were installing the shielding over a vulnerable spot on the space station. (March 30, 2017) (Sign up for our free video newsletter here <http://bit.ly/2n6VKPR>)
